The Effect of Limestone Aggregate Paths on Peat in the Yorkshire Dales

1. Purpose of this Report

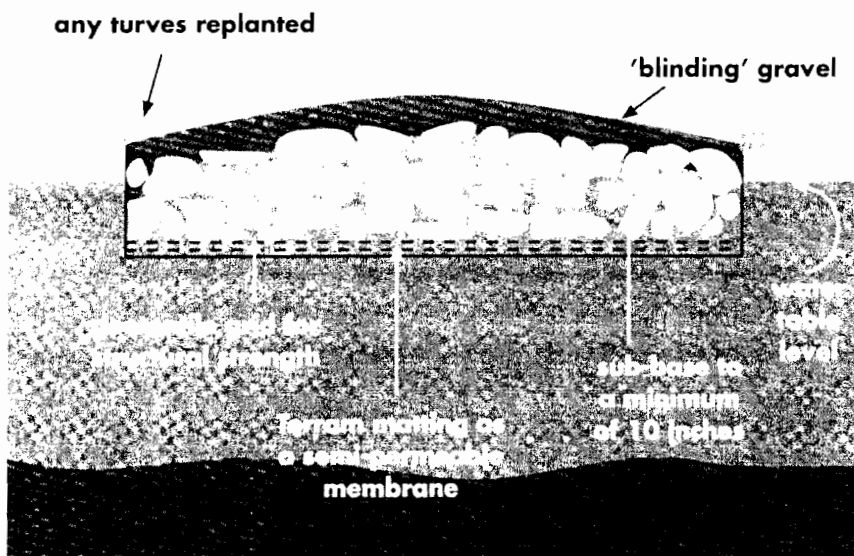
Cross section of a floated aggregate path over peat

(Source: Davies and Loxham 1996)

Over very soft ground such as deep peat, geotextiles membranes used in civil engineering, are often used for the sub-base. The geogrid and aggregate in effect float

over the structurally weak peat, creating a 'raft path'. An aggregate path laid directly on soft ground will soon fail, as the stone gets 'punched' down into the sub-grade, and fine material from the sub-grade is 'pumped' upwards by the action of passing users creating a mud or bog bath. The geotextile keeps the aggregate separate from the peat, and by keeping the aggregate all together, gives structural strength to the path without the need for a thick supporting base layer (see diagram above).

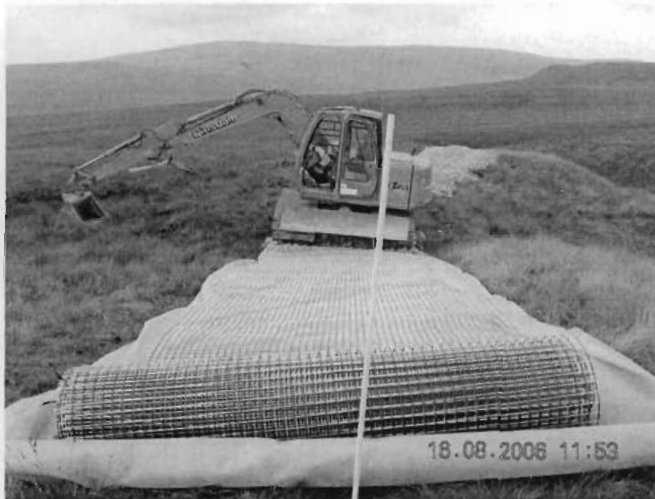
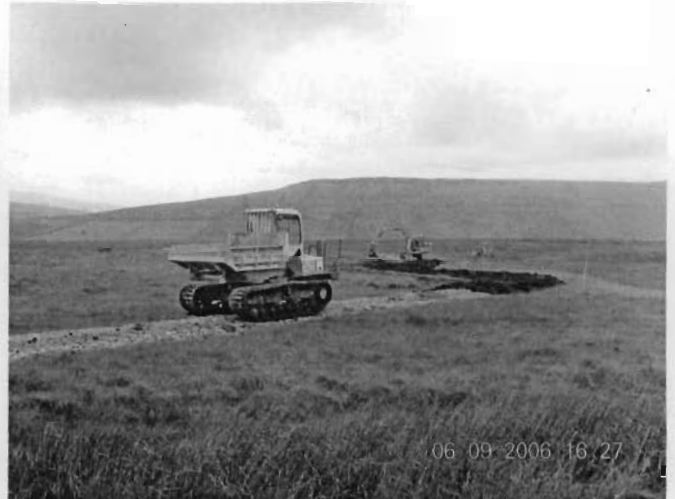
Floating a limestone aggregate path over peat - an example at Newby Head

Geotextile rolled out over the moor, aggregate is then placed over it. A drainage ditch is created alongside, turfs removed are placed along the edges of the geotextile to blend it into the surroundings. NB Tracked vehicles are used during construction to minimise pressure on, and compaction of the peat below.

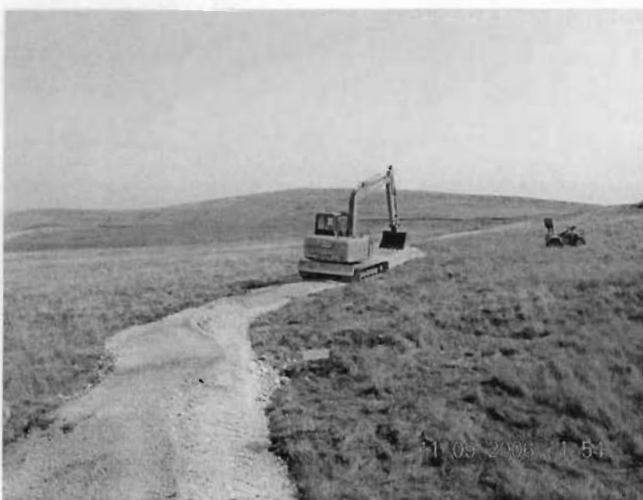
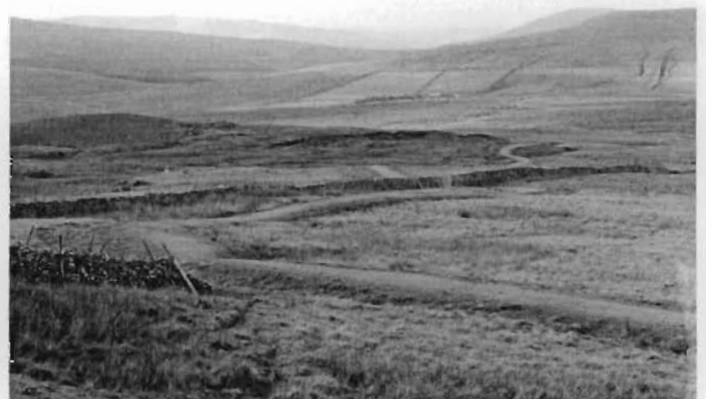
The path appears 'raw' until the limestone aggregate weathers and the grass sward becomes established. NB visual impact of the path is minimised, as far as possible, by careful positioning within the landscape, and avoidance of straight lines through the introduction of curves.

A stable path soon re-vegetates (note green edges of path shortly after completion). The limestone aggregate above has peat mixed in it. Re-vegetation is also encouraged through seeding the path with an appropriate native grass seed mix. Trials were undertaken by the Three Peaks Projects in the 1980s on similar aggregate floated paths to find the best methods. (See appendix 1 for more information about these trails and Appendix 2 for list of species that usually colonise after path construction). Many factors including altitude, aspect, and amount of rainfall affect the rate of re-vegetation.

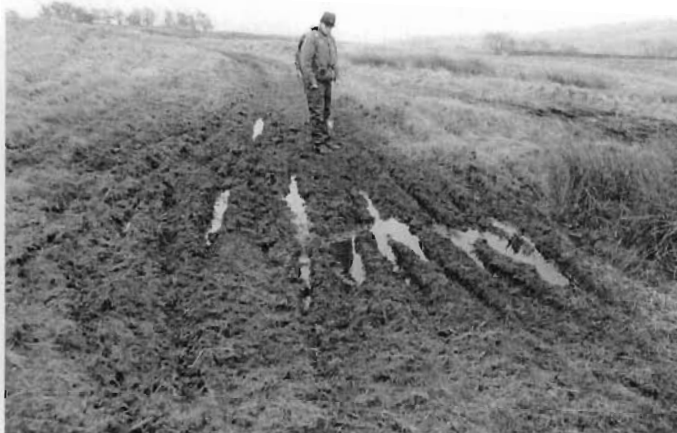
An example of maintaining a damaged path - the 'Highway' - Wensleydale

User damage to the peat surface of the right of way creates pools of standing water and loss of vegetation over a widening area, as users seek to avoid these wet areas.

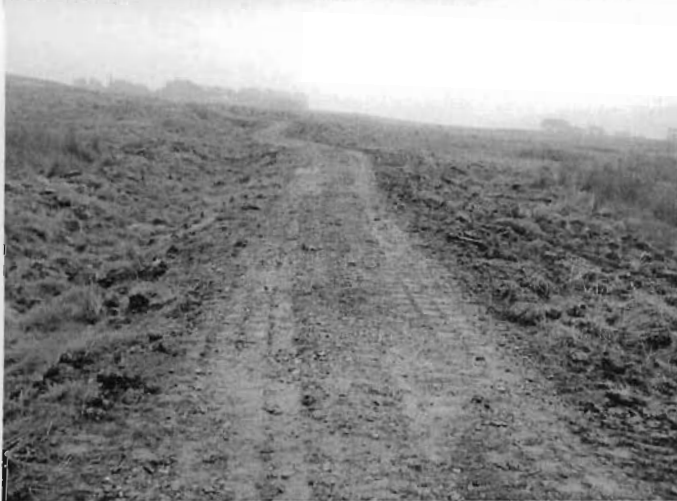
As part of the maintenance aggregate is imported to the site, and the track surface raised above the surrounding water table. Note also drainage ditch on left

Track is seeded with a native seed mix to encourage vegetation to re-establish.

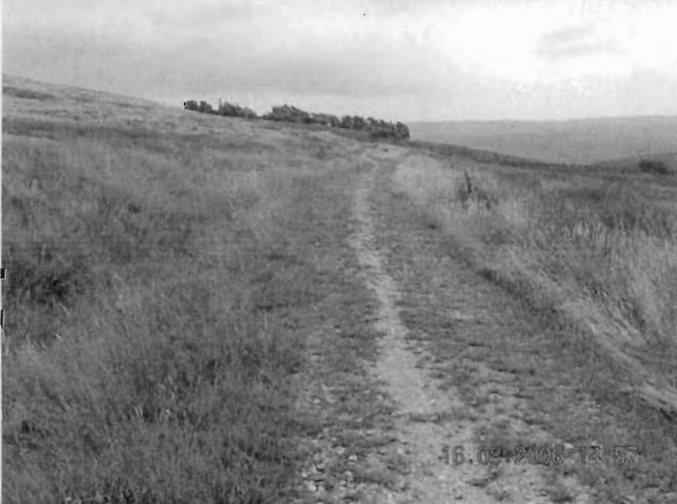
Two years later the aggregate surface has almost disappeared and the path narrowed through the colonisation of native grass species, and encroachment of soft rushes along the edges of the track and drainage ditch.
