BAT SURVEY

15 Back Lane, Sedbergh

BAT & NESTING BIRD SURVEY

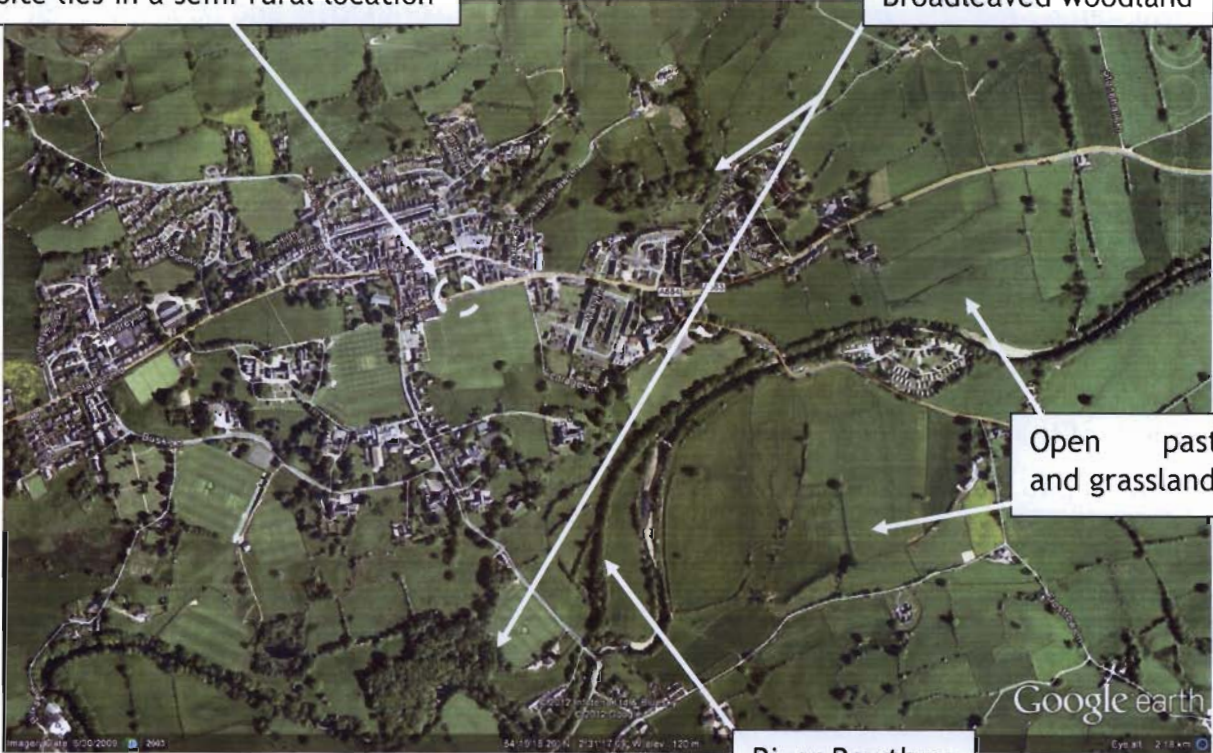
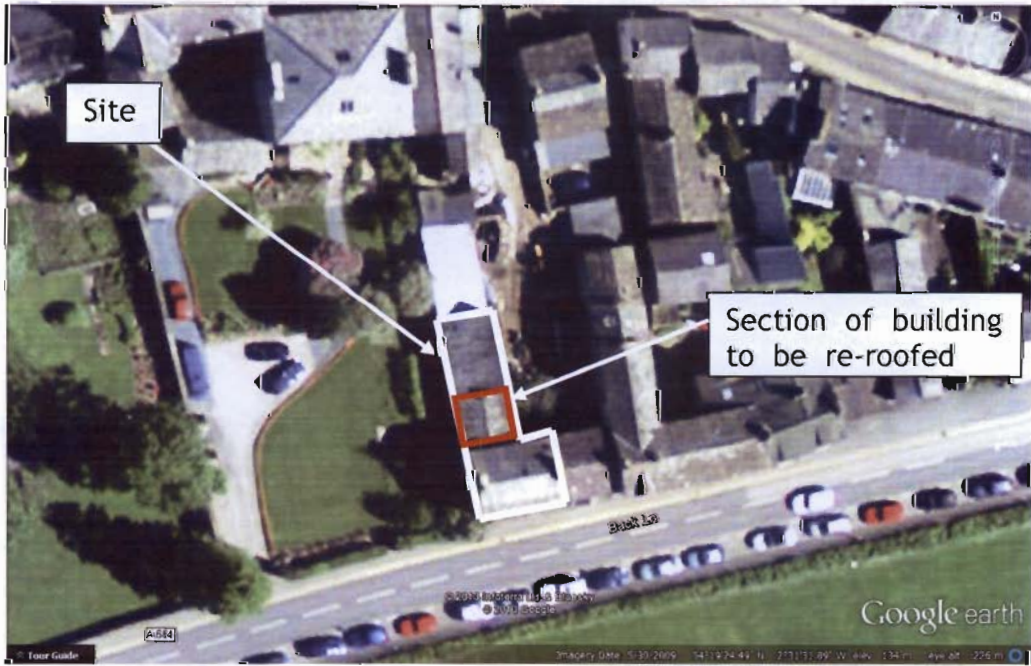
Figure 2- Satellite Image of surrounding area

The site lies in a semi-rural location

Broadleaved woodland

Open pasture and grassland

River Rawthey

Site

Section of building to be re-roofed
